| AF72.10-P-1000-01D | Replacing sliding bushing on door retaining strap bolt. | |

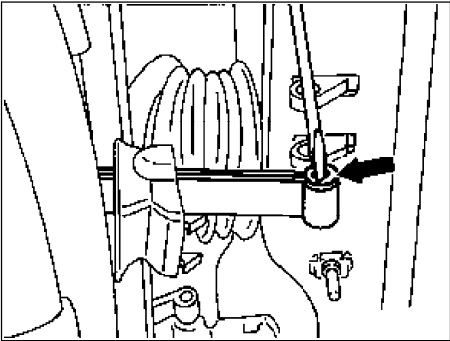
P72.10-0038-01

- 1 Remove retainer on door retaining strap bolt.
- 2 Remove door retaining strap bolt.  
⚠  
Avoid damaging paint.
- 3 Pry out sliding bushing (arrow) with screwdriver.

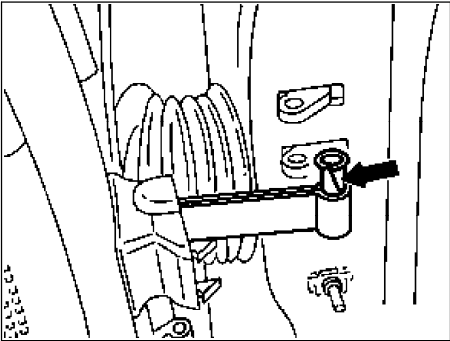
P72.10-0039-01

- 4 Install steel bushing (arrow).
